# The Gotthard Road Tunnel Fire: 20 Years On

Petr Pospisil, Principal Engineer with HNTB's Ventilation and Fire Life Safety team in North America, was working as a ventilation designer on the Gotthard Road Tunnel's refurbishment when a major fire occurred in 2001. Twenty years later he looks back at the incident and discusses lessons learnt.

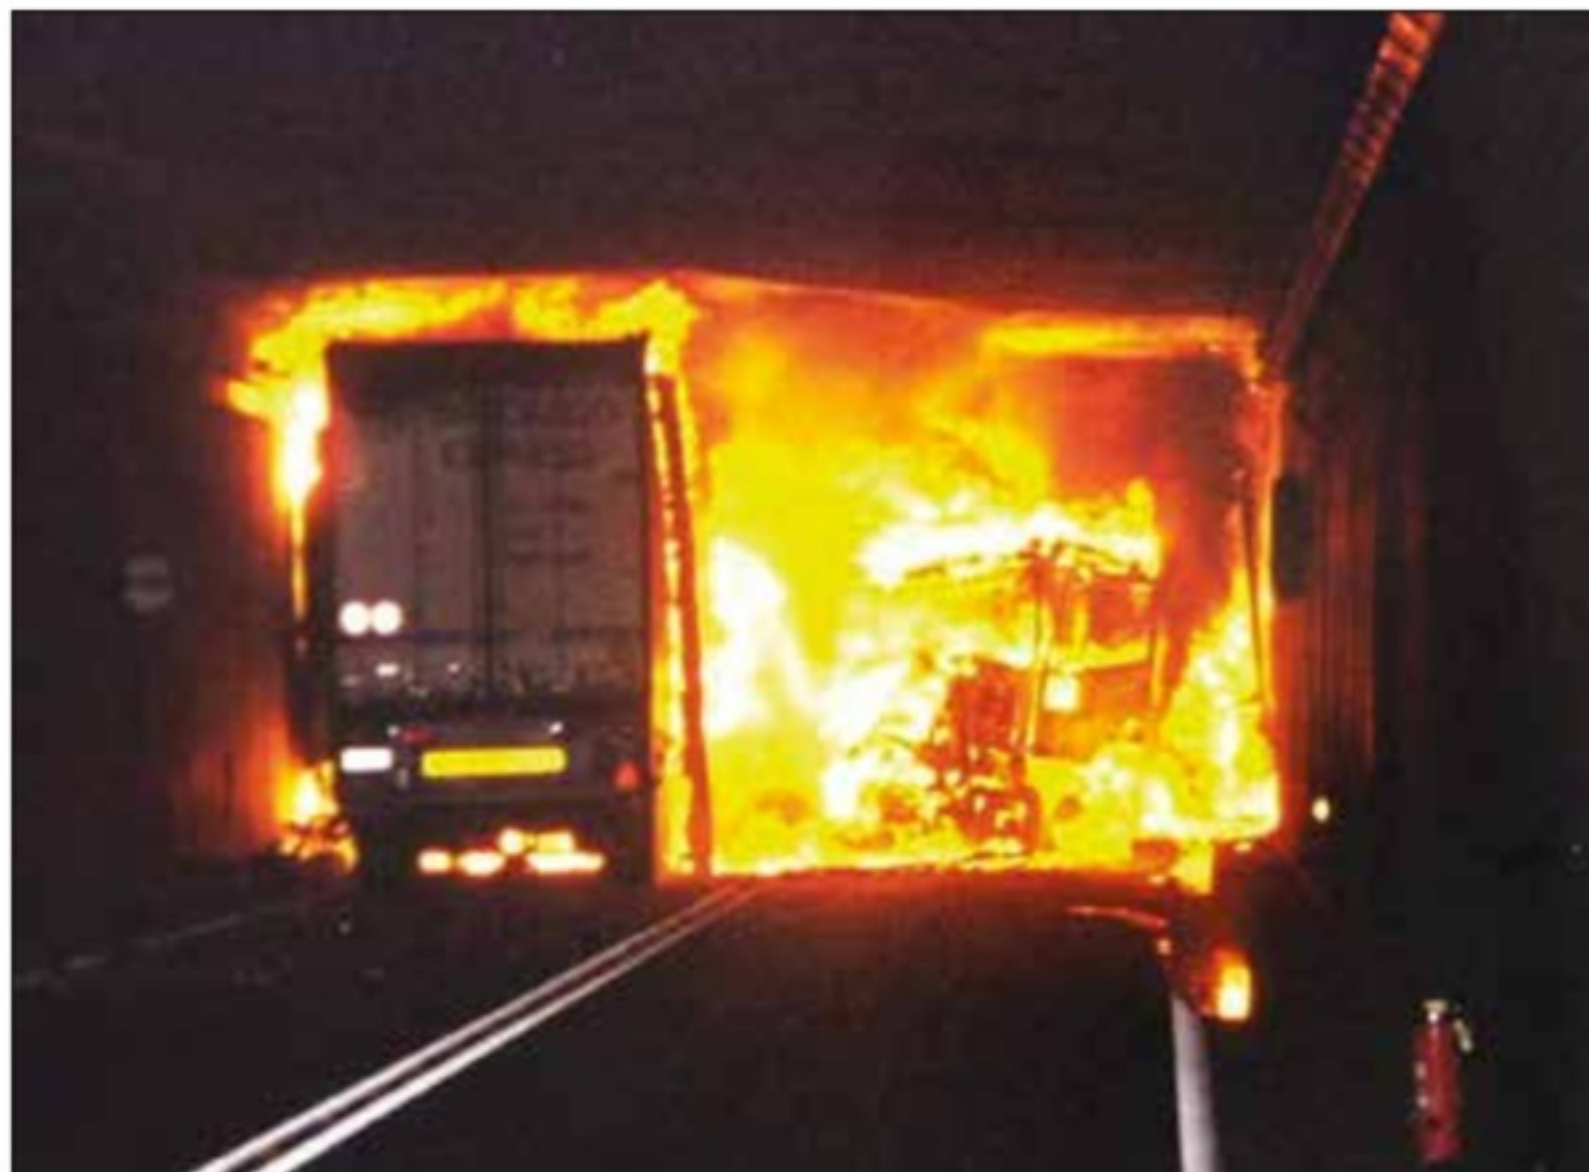
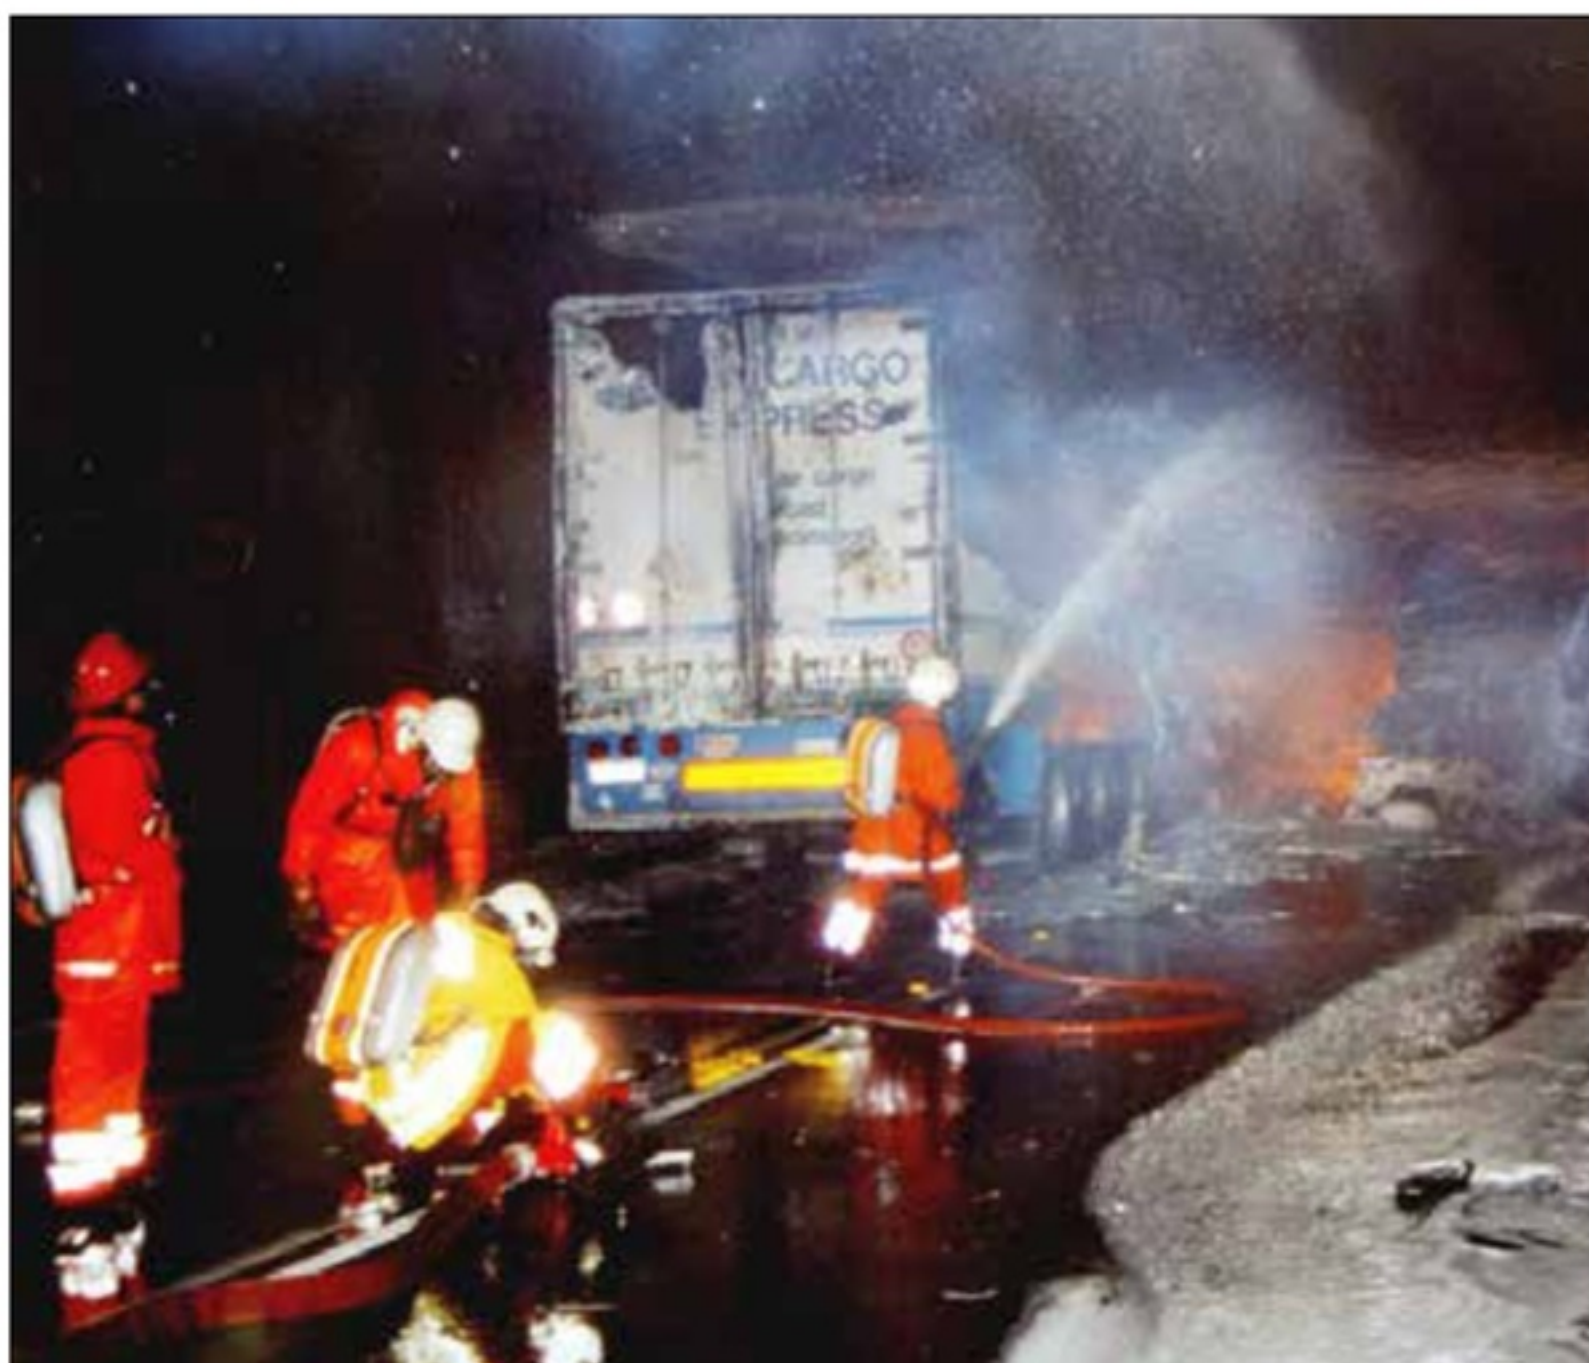
Figure 1: Fire in the Gotthard road tunnel 2001

On October 24, 2001, a collision and subsequent fire in Switzerland's Gotthard Road Tunnel resulted in 11 fatalities and serious damage to the tunnel structure and equipment. As one of several major tunnel fires that gained extensive media coverage at the time, the incident prompted many publications on tunnel safety, e.g., The Handbook of Tunnel Fire Safety, Chapter 3<sup>[2]</sup> and the report by the Criminal Investigation Team<sup>[1]</sup>. The picture of the two burning trucks, taken by a police officer approaching the fire from the south a few minutes after the collision, became an iconic image for road tunnel fires, see Figure 1.

The photo shows some important features of the incident. First, the truck on the left that caused the accident is on the wrong side of the road (not being in the UK). Rather, the driver lost control of his vehicle and swerved into the opposite lane of traffic. Second, the photo was taken from the clear side; all the heat and smoke was driven in the other direction. The south (upwind) side of the fire remained fully accessible. In fact, the back of the truck on the left remained intact until the fire was extinguished hours later. The target conditions of some tunnel ventilation standards, i.e. avoiding backlayering of smoke, were maintained.

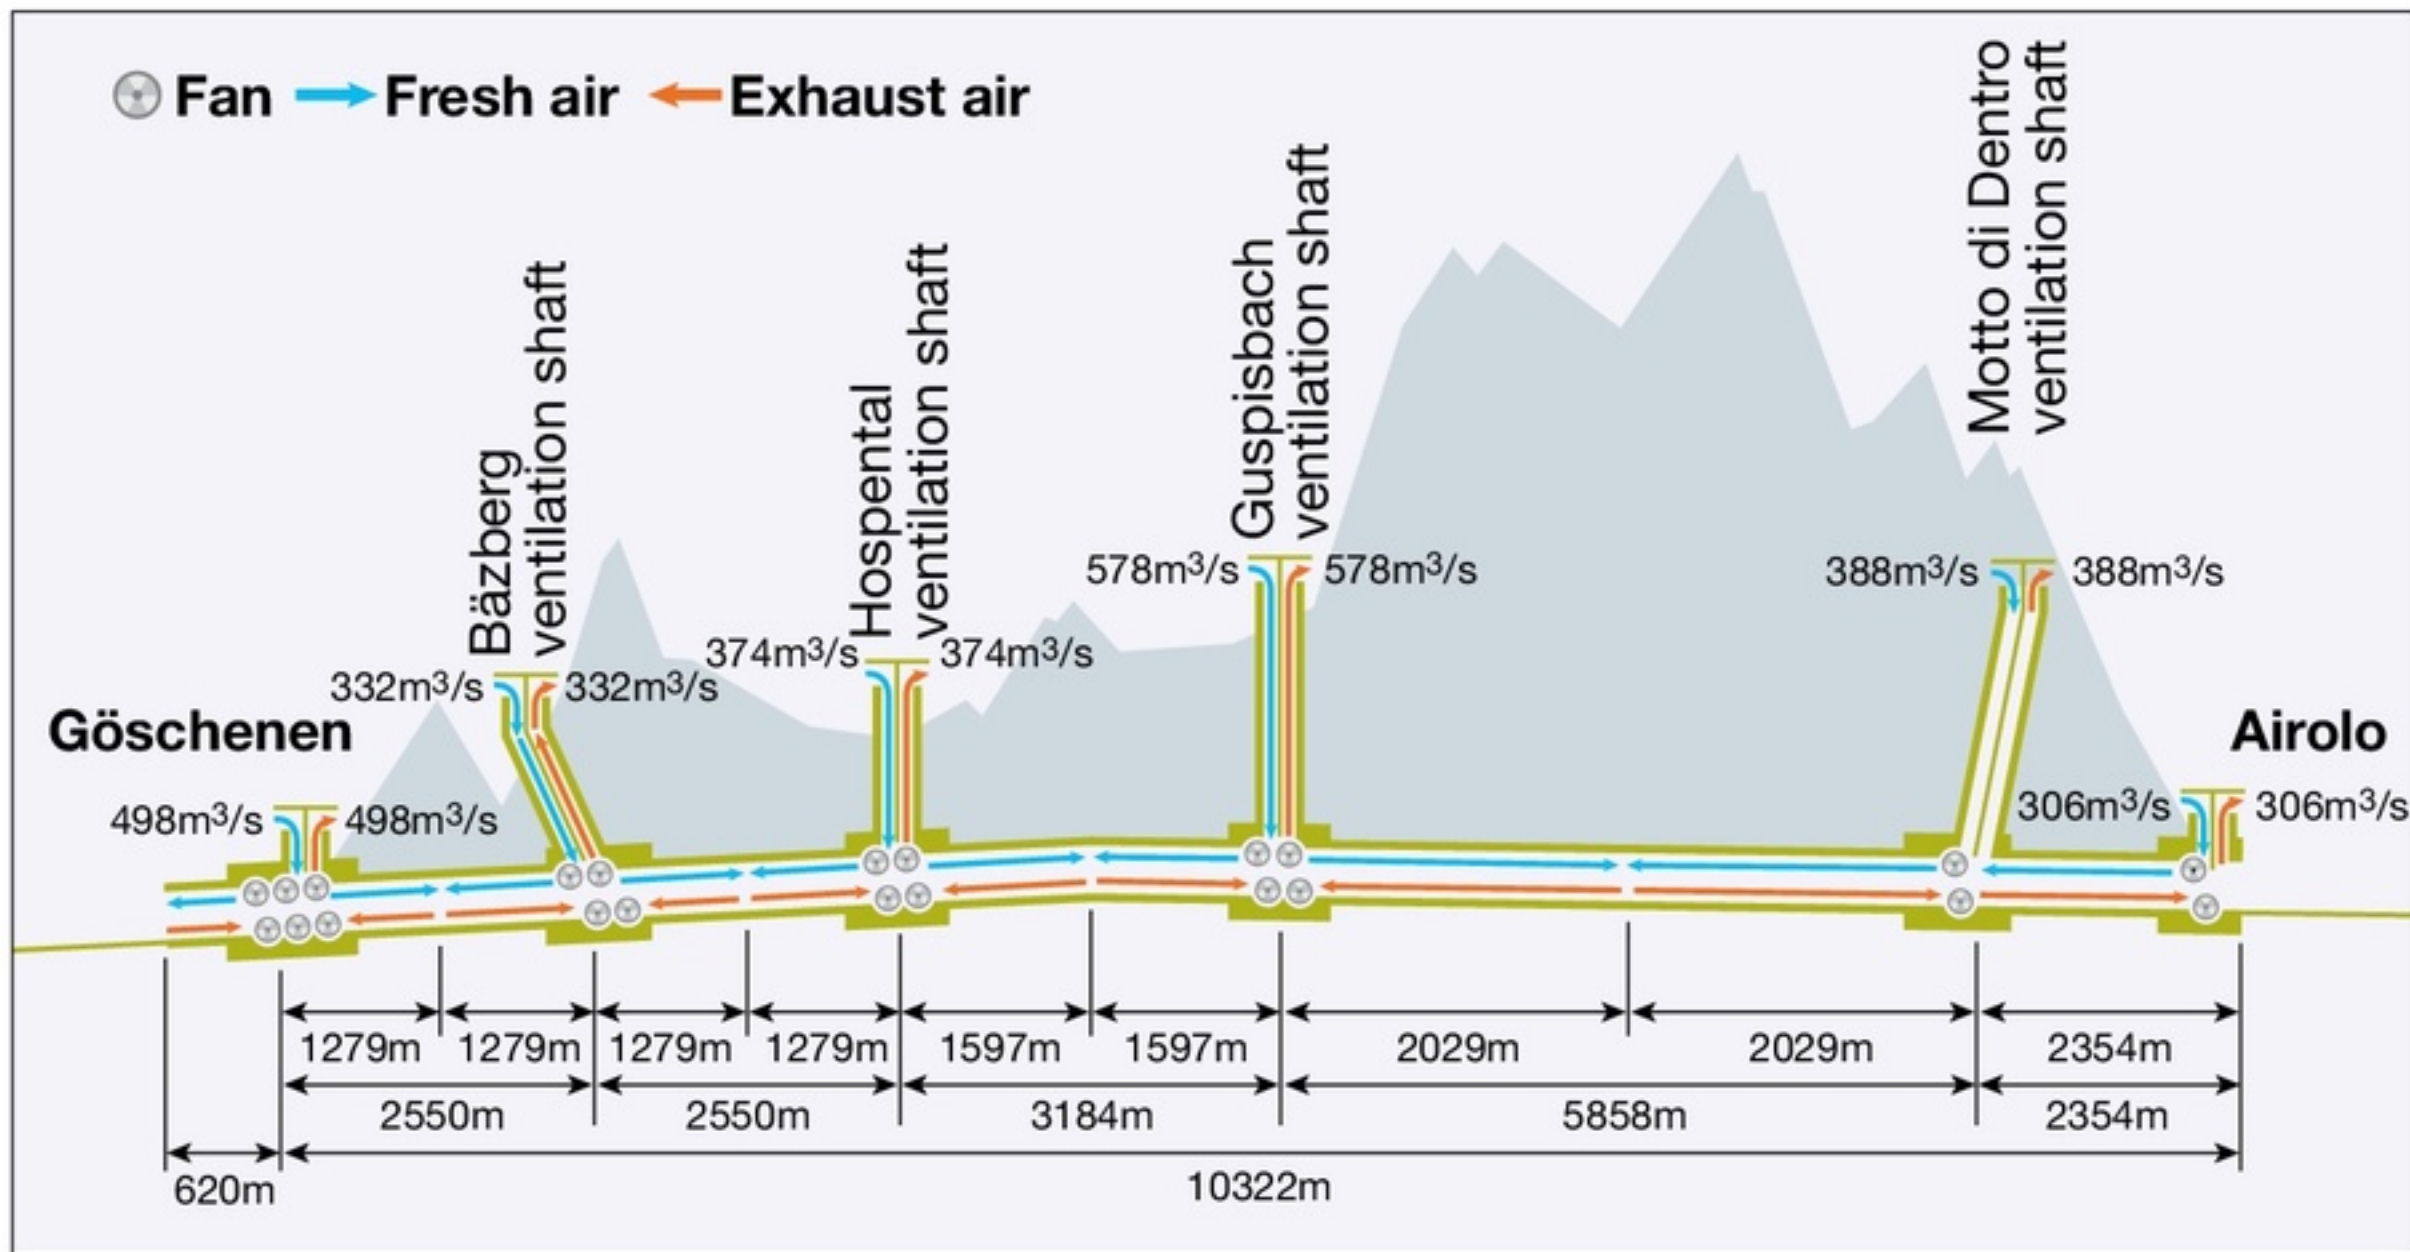
Figure 2: Schematic of the original ventilation system

- The reaction time of the emergency ventilation measures, which took several minutes to commence following the fire alarm, must be improved.
- Emergency exits should very clearly indicated and drivers instructed to find and use them.
- The extraction capacity should be increased by operating the line exhaust in both sections of a ventilation zone, see Figure 2. An important detail in the fire development four years later.

The flow velocity at the fire location reached up to 7.5m/s, driving smoke more than 2.5km towards the north, to the middle of ventilation section 9 (see Figure 2). Those excessive flow velocities fanned the fire and accelerated the spread of smoke. That was caused by the following forces:

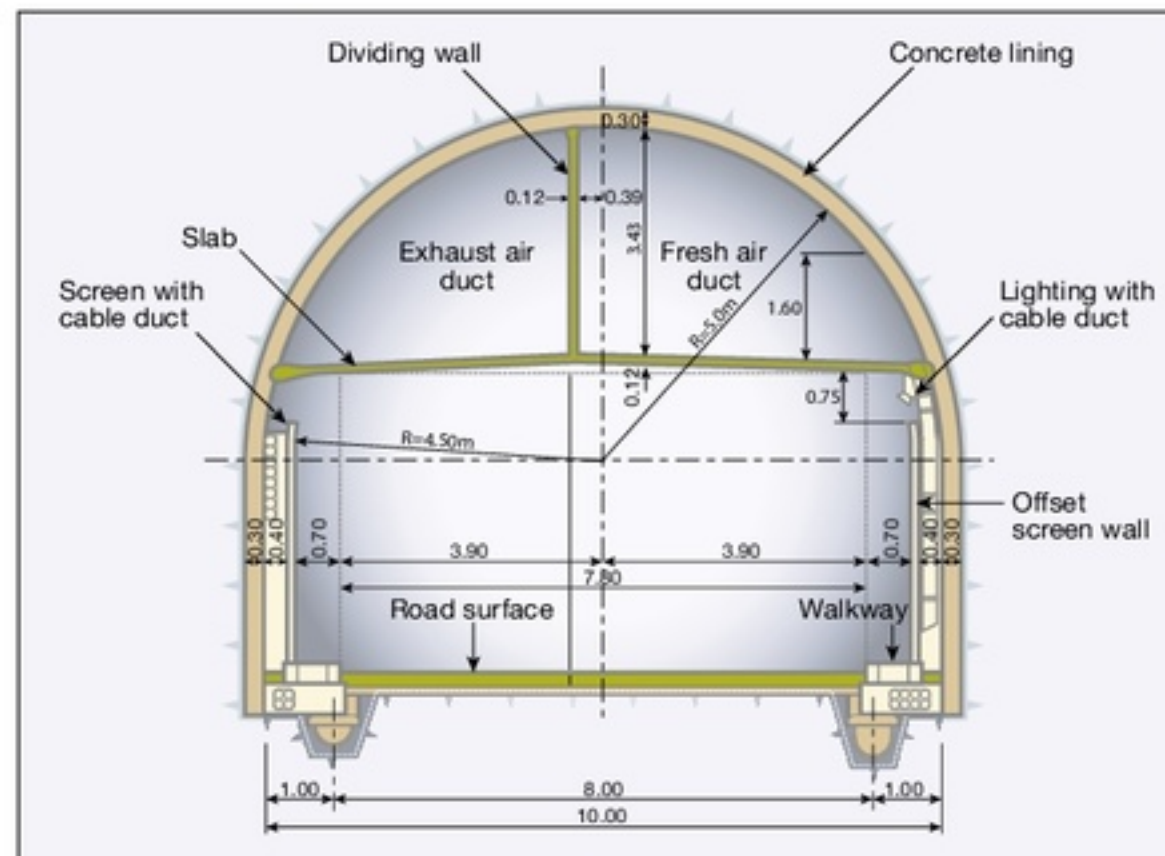
Figure 3: Tunnel cross section with supply and exhaust ducts in the ceiling

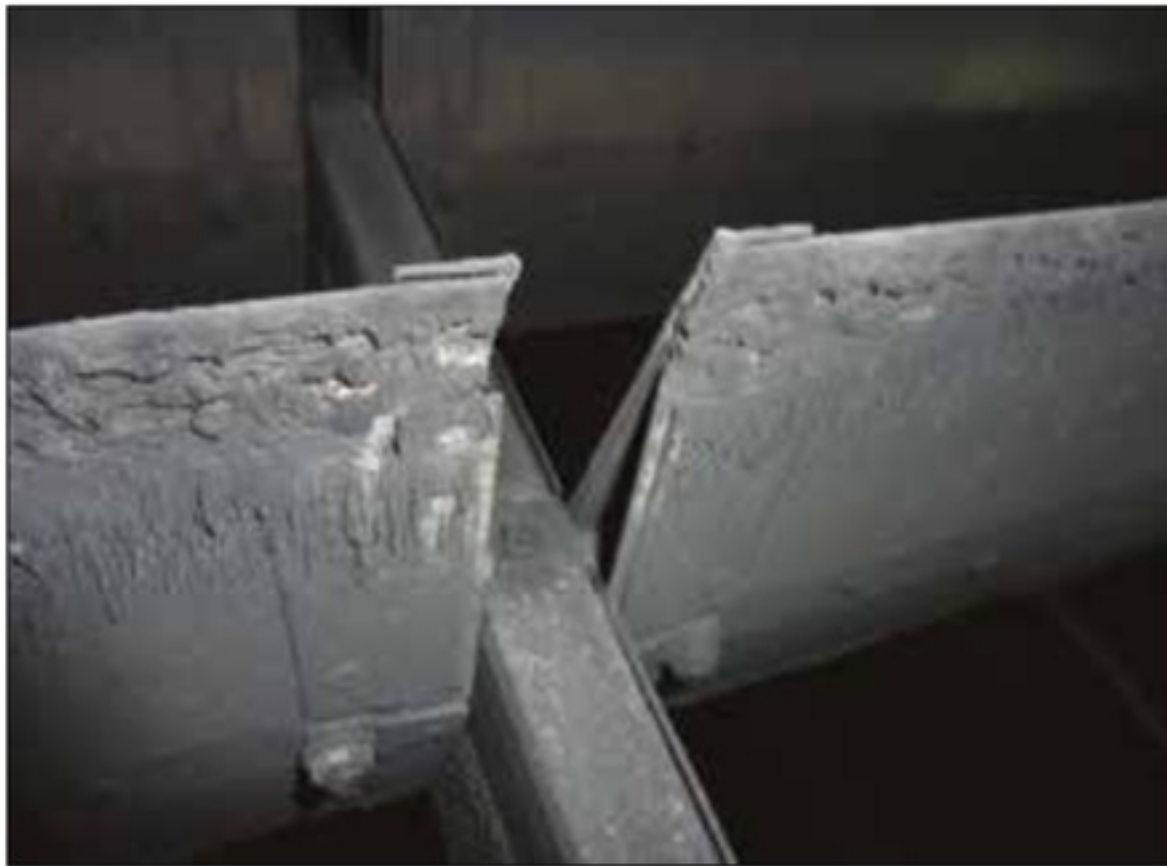
Figure 4: Exhaust damper blades in the Gotthard Road Tunnel after 10 years of operation

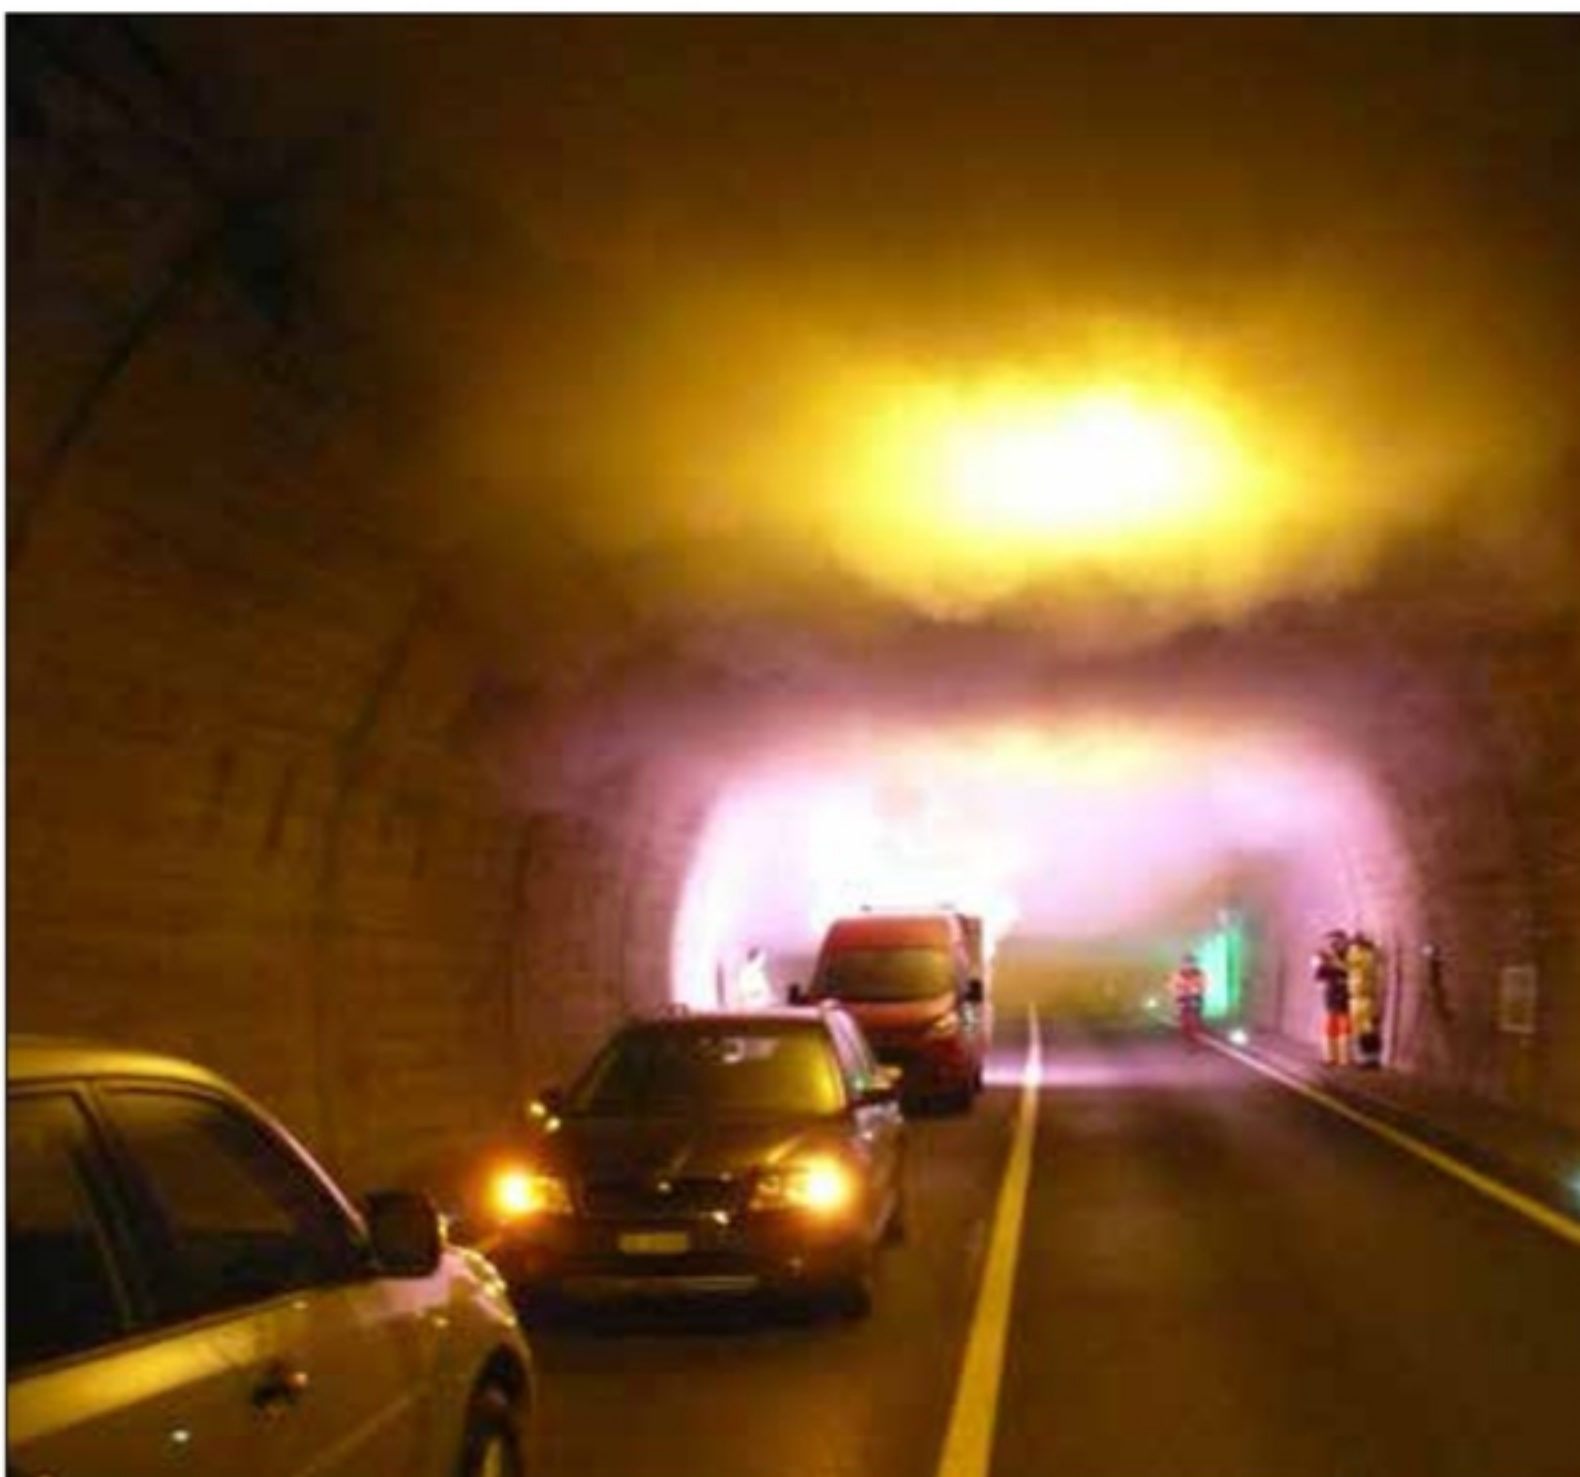
Figure 5: Controlled smoke layering during a hot smoke test in a road tunnel
